## Northlake Home Inspections of Charlotte

### Property Address

1234 Anywhere Lane Charlotte NC 28215

### **Pre-Drywall Inspection**

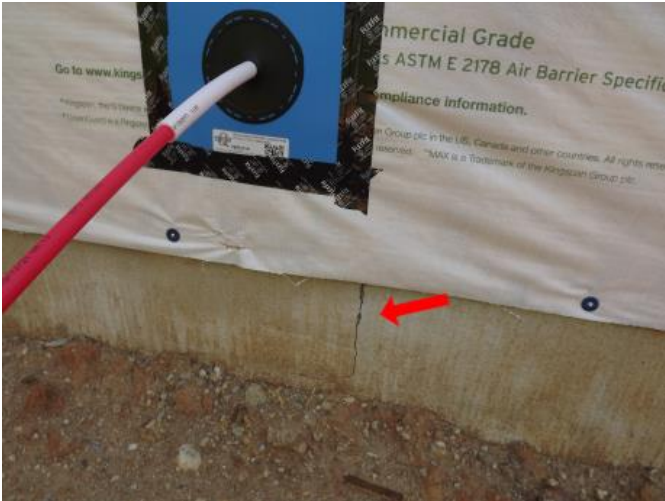
Observed cracks in foundation walls at Left side and rear. Exposed and bent sill anchor bolt. Damaged CMU block to Left of garage. Moisture can penetrate these areas causing additional damage. Recommend further review with builder / contractor for repairs as needed.

Crack in foundation wall at Left side.

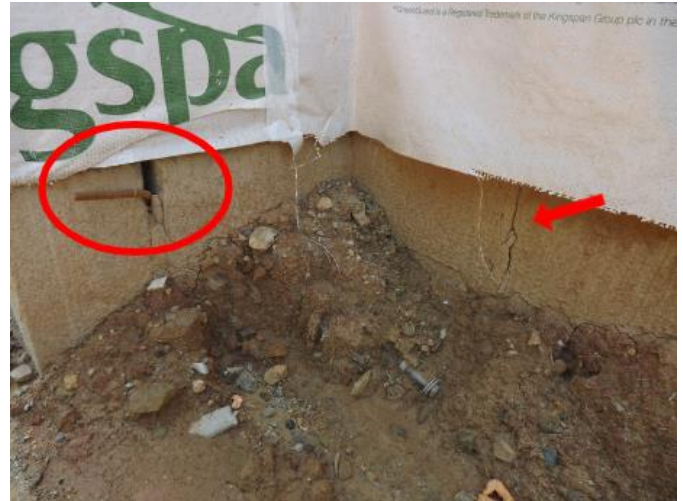
Cracks in foundation wall at rear. Exposed sill anchor bolt.

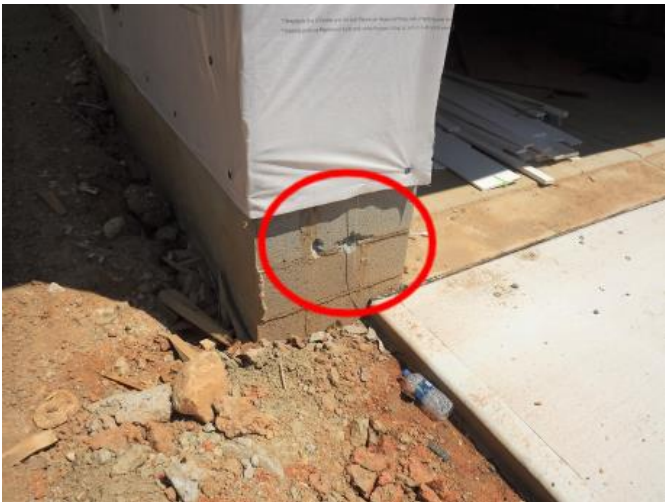
Damage at CMU block to Left of garage.

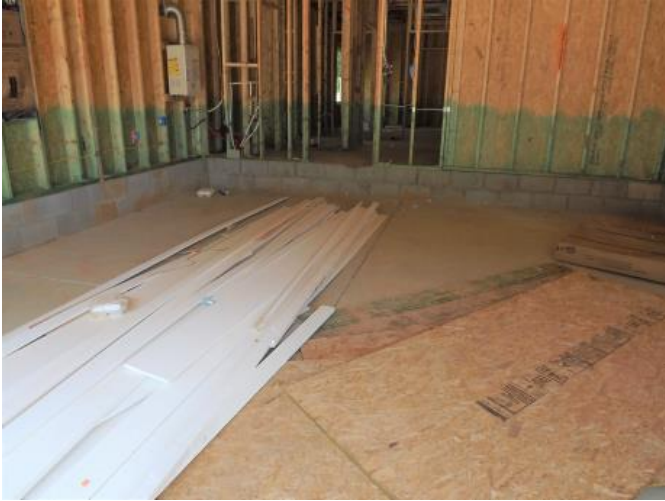
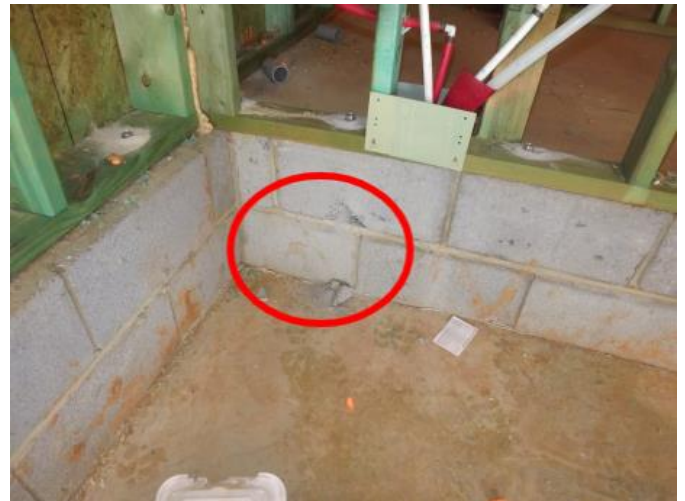
The garage foundation primarily appeared to be in serviceable condition at the time of the inspection. Observed damaged CMU block at Left rear corner. Recommend further review with builder for repairs as needed. Limited inspection due to construction material present.

Cracked CMU block.

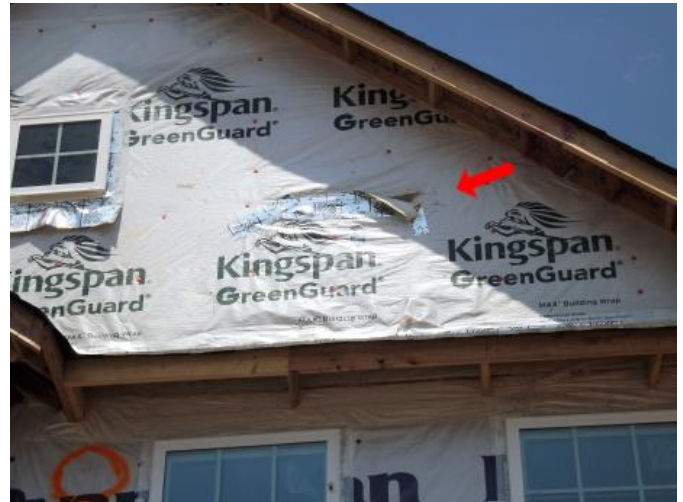
The visible and accessible portions of the exterior wall coverings primarily appeared to be in serviceable condition at the time of the inspection. Observed loose tape / house wrap at front and missing section of house wrap at front Right side. Recommend further review with builder for repairs / taping as needed.

Loose tape / house wrap at front.

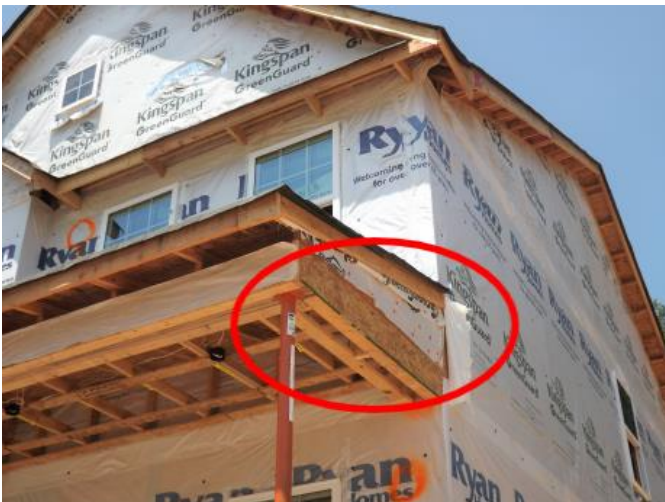
Missing / loose house wrap at Right side.

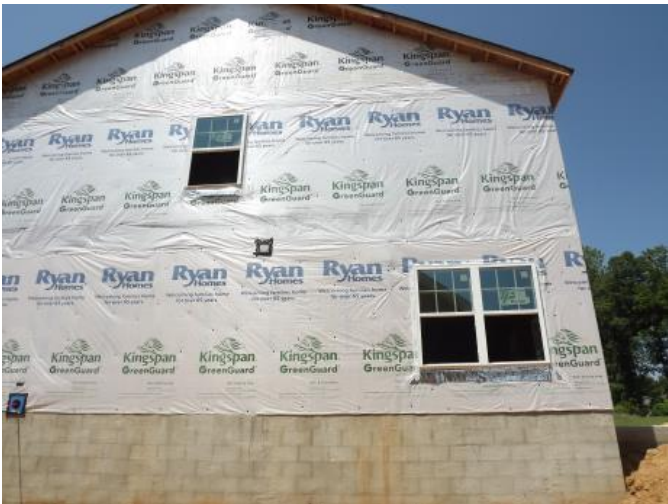
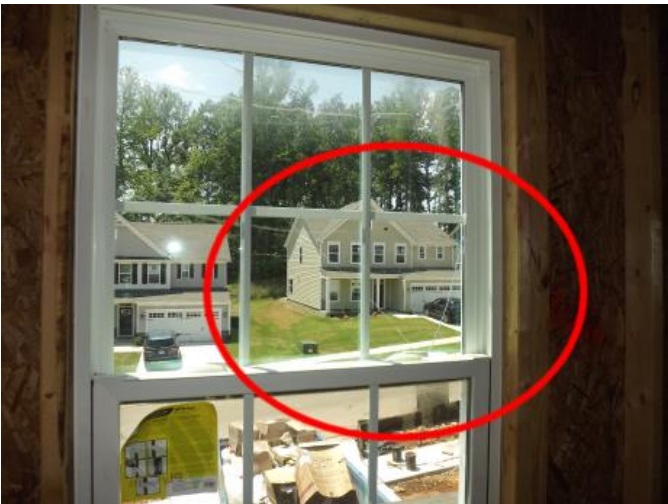
Broken glass pane(s) were observed at second floor front window. Recommend further review with builder for repair / replacement as needed.

Cracked window at second floor.

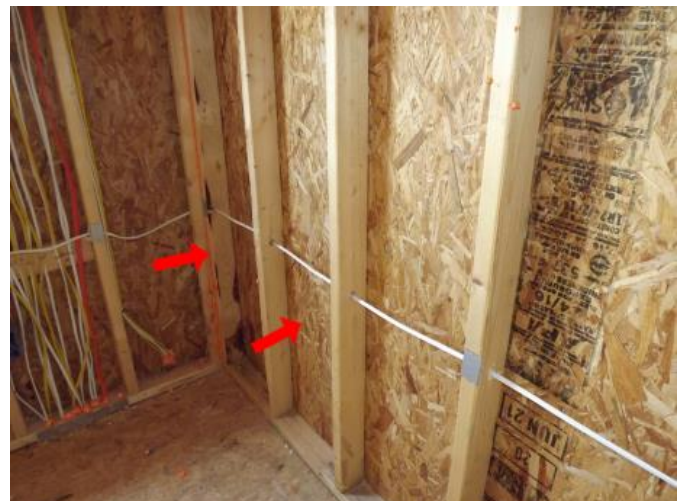
Observed missing stud guards at various locations including first and second levels. Stud guards protect electrical wiring and plumbing lines from fastener damage when drywall is installed. Recommend further review of all studs to ensure stud guards are present as needed.

Missing stud guards at second floor loft.

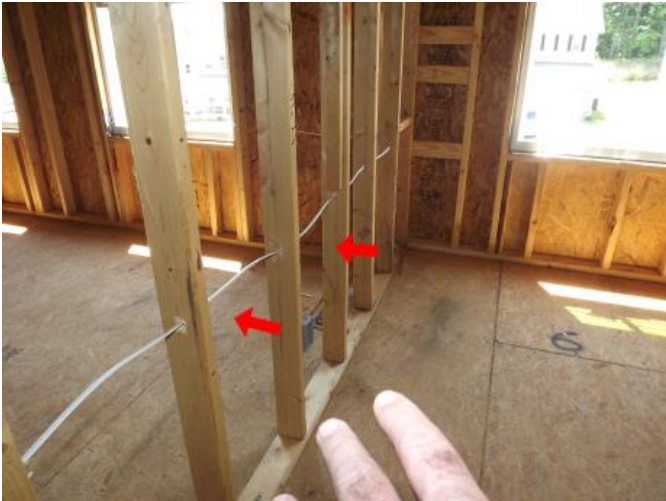
Missing stud guards at laundry room.

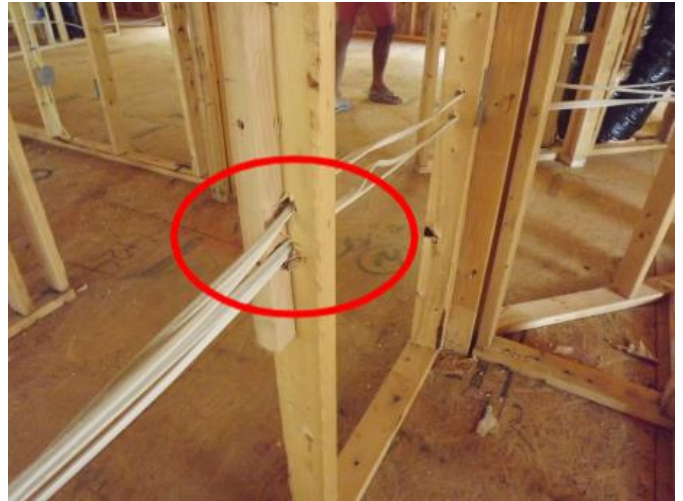
Missing stud guards at 4th bedroom.

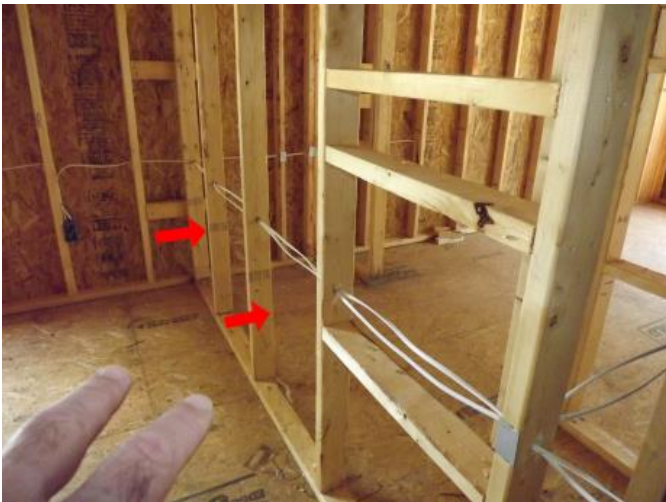
Missing stud guards at 4th bedroom.

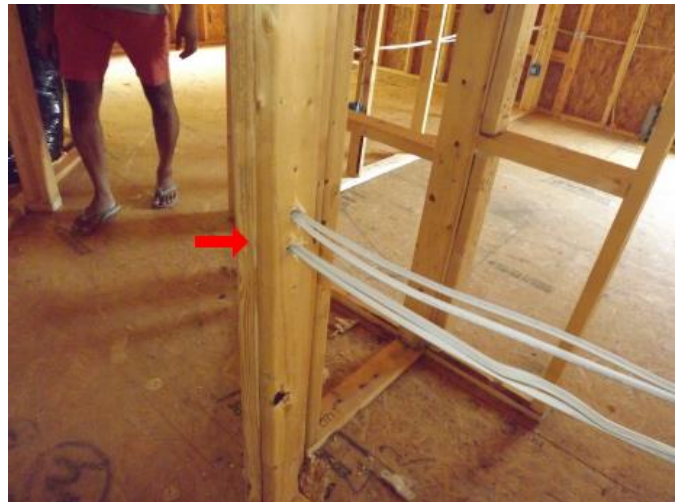
Missing stud guards at second floor hallway.

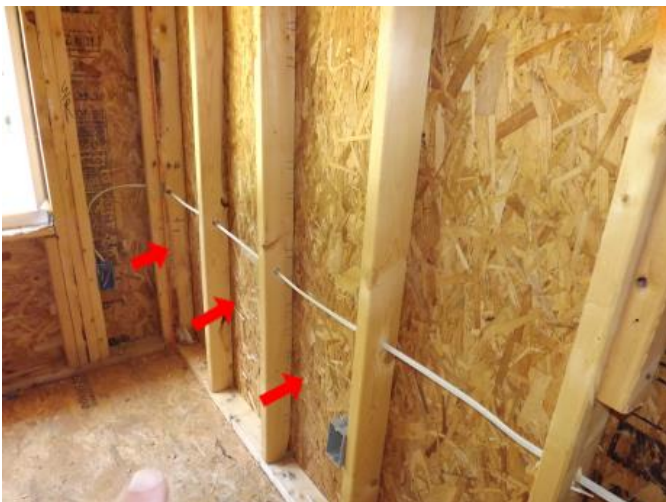
Missing stud guards at 5th bedroom.

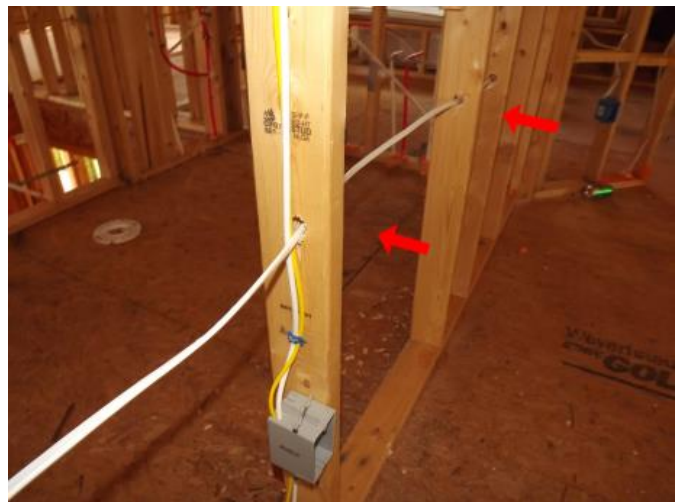
Missing stud guards at master bedroom.

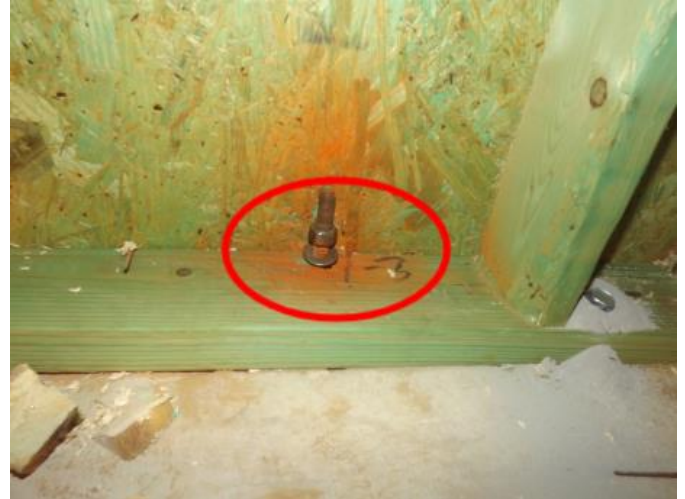
Observed loose anchor bolt fasteners at various locations of the perimeter sill plates. This can effect the stability and strength of the exterior wall structure. Recommend further review to ensure all anchor bolt nuts are properly secured as needed.

Loose sill plate fastener at kitchen.

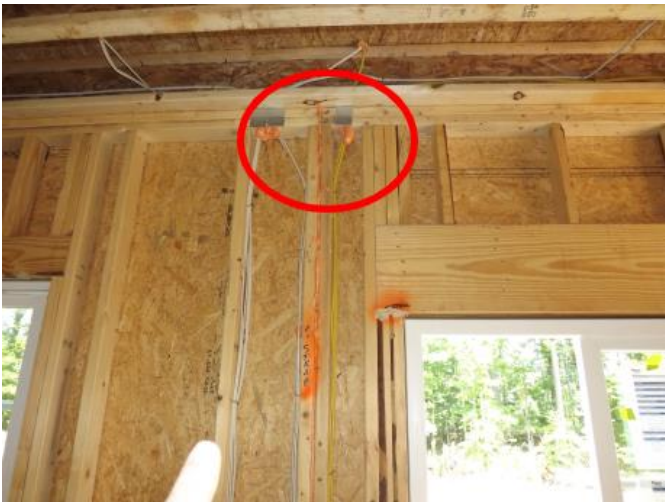
Observed missing stud strap at rear entrance. Stud straps or ties reinforce and strengthen the wall structure and assist with stabilizing the wall and roof in the event of high winds. Recommend further review with builder to ensure stud straps are present as needed.

Missing stud strap near rear sliding glass.

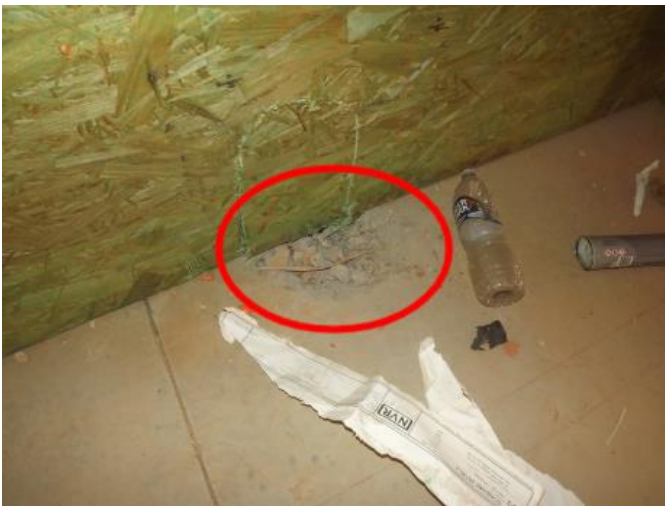
The general condition of the visible and accessible portions of the floors primarily appeared to be in serviceable condition at the time of the inspection. Observed damaged concrete at kitchen plumbing lines. Recommend review with builder for further evaluation and repairs as needed.

Damaged concrete at kitchen.

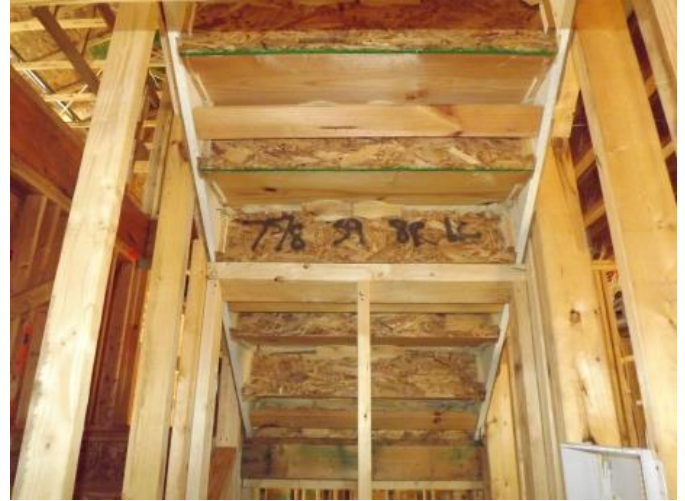
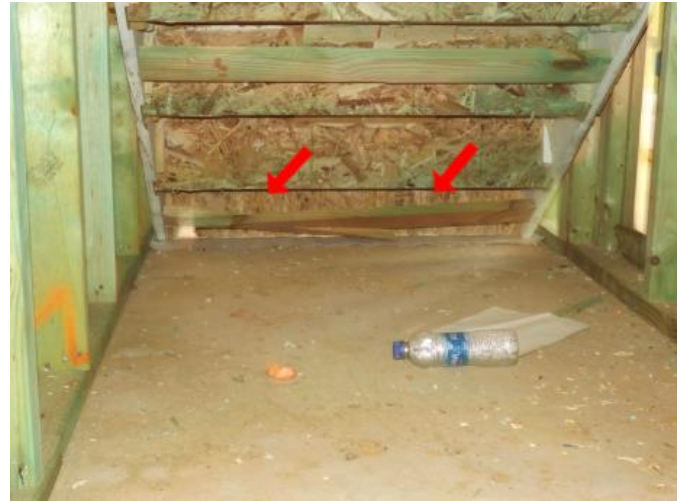
Observed damaged bottom lateral support at stairs. This can effect the strength and stability of the stair system. Recommend review with builder for further evaluation and repairs as needed.

Cracked / damaged support at underside of stairs.
