Northlake Home Inspections of Charlotte

Property Address

1234 Anywhere View Dr Charlotte 28209

Report Information

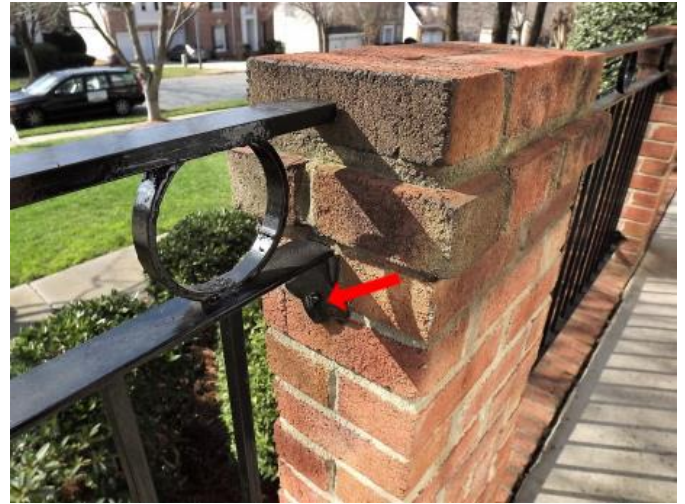
2.1) Front Entrance Conditions

Missing mortar.

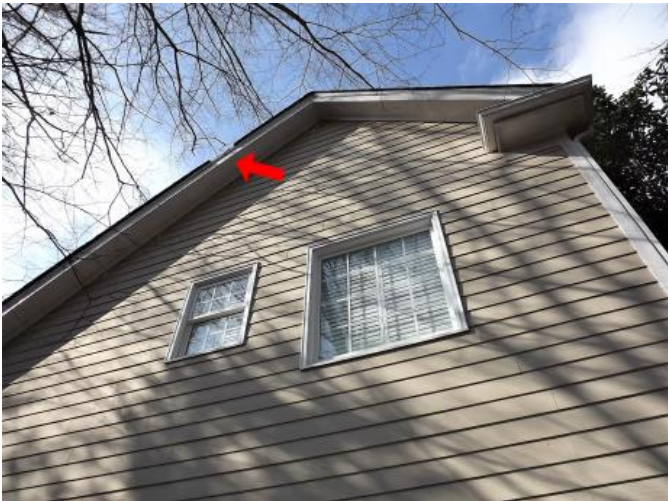
5.1) Roof Covering Condition R

Overall roof appears serviceable. However, there are damaged or missing shingles observed in one area at the right side of home. Recommend further evaluation and repair as needed by a qualified / licensed contractor.

Damaged shingle(s).

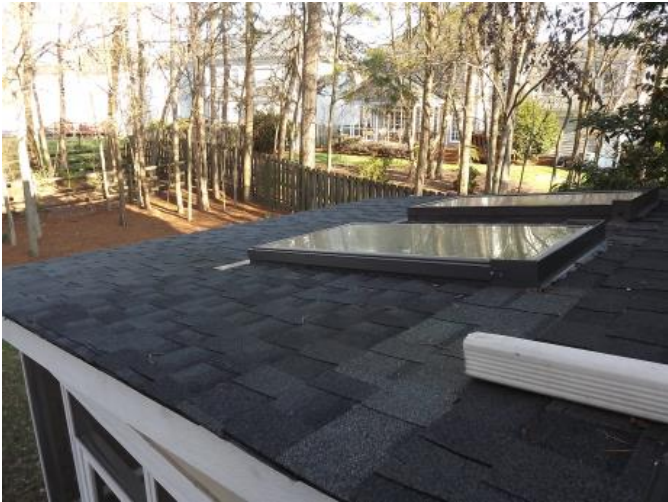
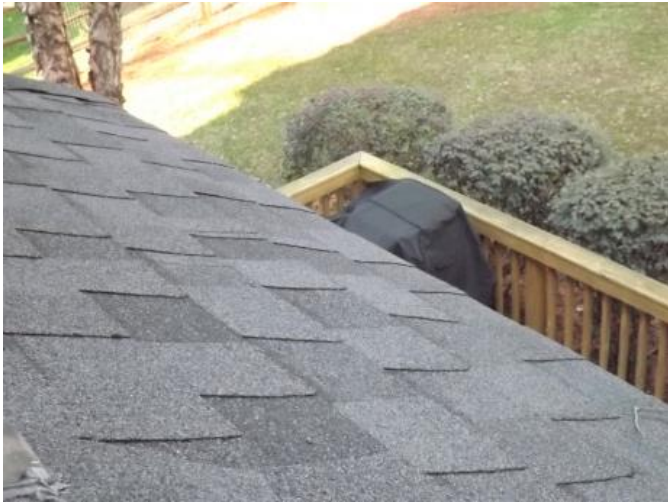
Damaged shingle(s)

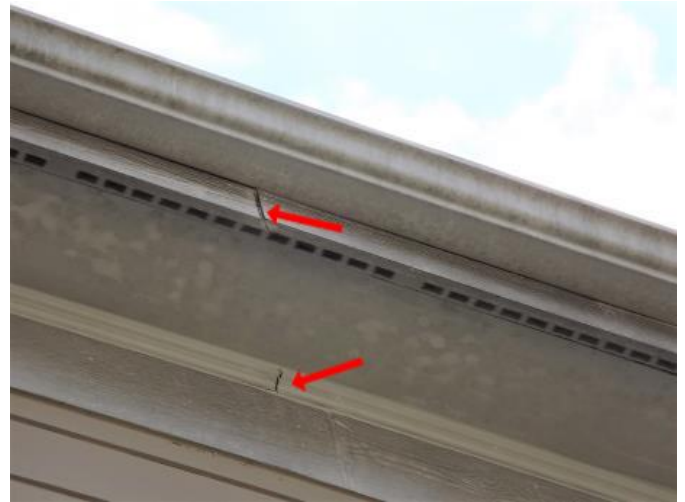
5.2) Flashing Conditions

Appears Serviceable. Trim and/or flashing separation on left side of home. Moisture could enter trim and/or wall. Recommend further evaluation and repair as needed by a qualified /licensed contractor.

Separation in flashing/trim.

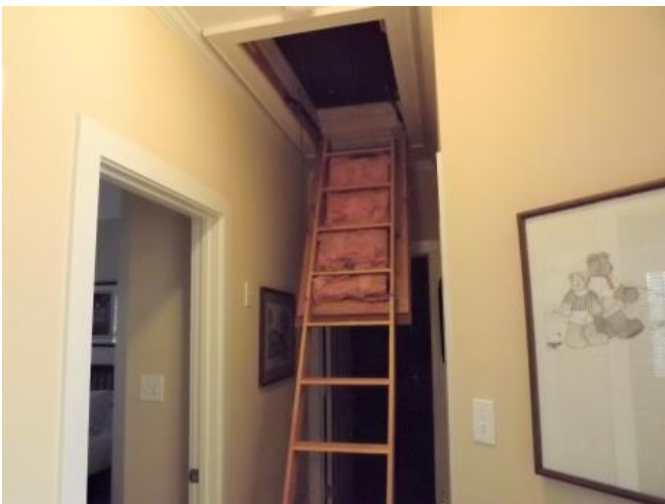
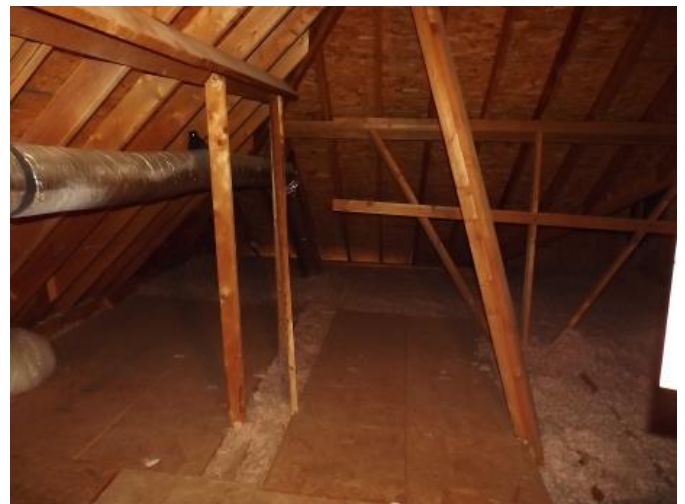
6.1) Attic Conditions

The visible and accessible portions of the attic appeared to be in serviceable condition at the time of the inspection. However, the pull down attic stair assembly is difficult to pull down due to the lack of a pull cord (must use an extension tool to grasp the door knob to pull open and down). Recommend installation of a retractable pull cord.

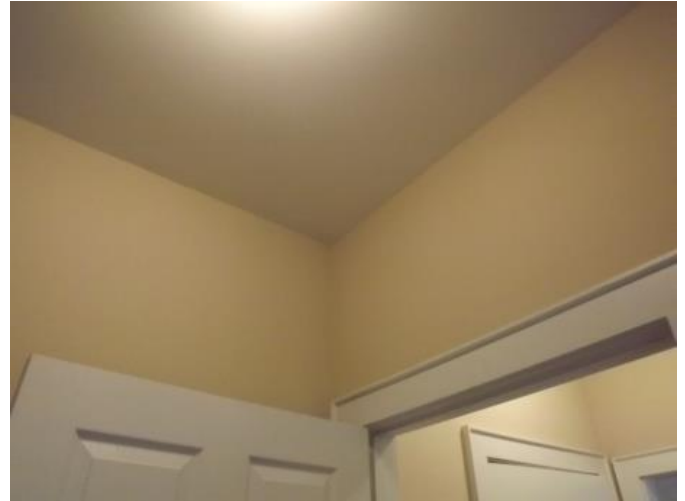
11.1) Wall Conditions

The general condition of the walls appeared to be in serviceable condition at the time of the inspection. Some minor cracking/loose tape at a drywall corner. Recommend further evaluation and repair as needed by a qualified /licensed contractor.

Cracked/loose drywall tape.

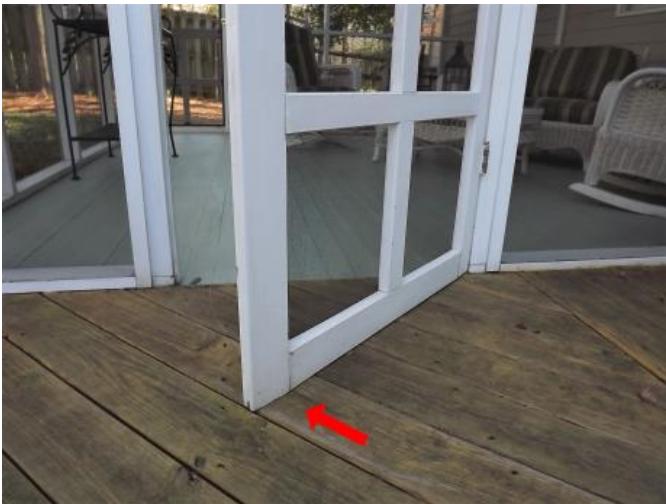
Appears Serviceable. However, both doors to covered patio drag floor at base. Recommend further evaluation and repair as needed by a qualified /licensed contractor.

Door drags on deck.

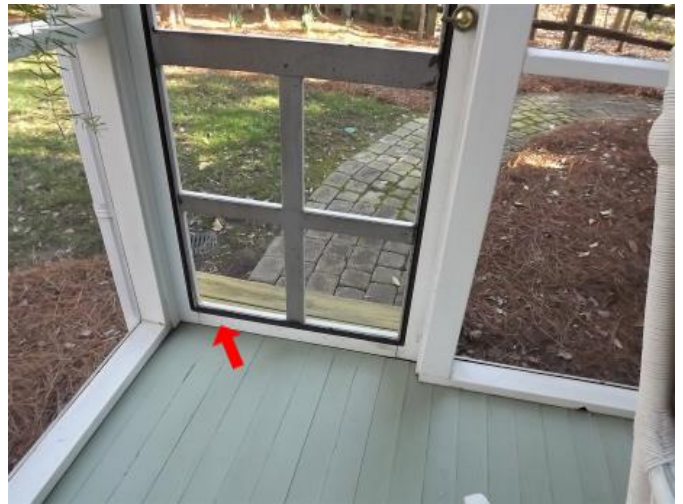
Door drags on step.

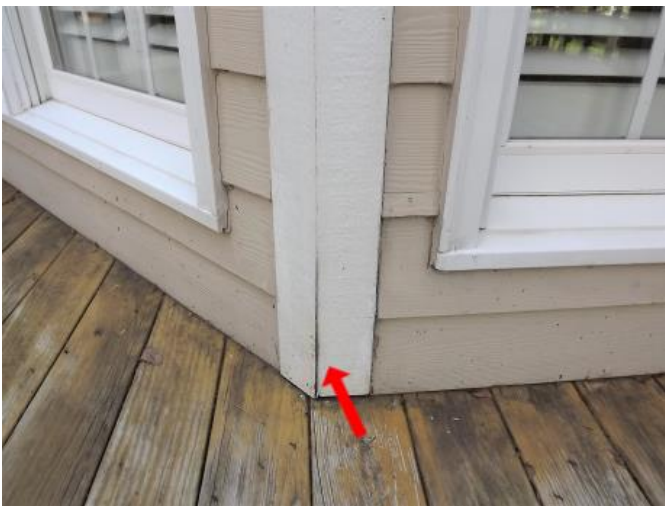
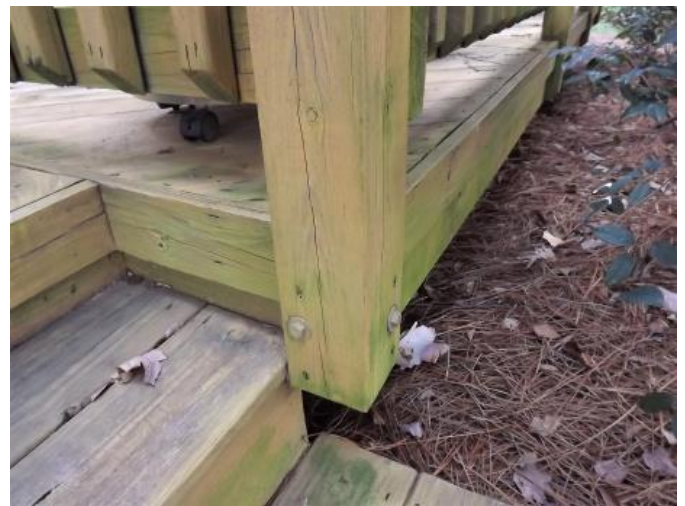
The general condition of the visible and accessible portions of the deck appeared to be in serviceable condition at the time of the inspection. There is a gap in the side wall trim at rear deck. Water could penetrate trim and interior of wall. Recommend further evaluation and repair as needed by a qualified /licensed contractor.

Gap in trim at rear deck.
