## Northlake Home Inspections of Charlotte

### Property Address

1234 Anywhere Lane Charlotte NC 28215

### **Pre-Drywall Inspection**

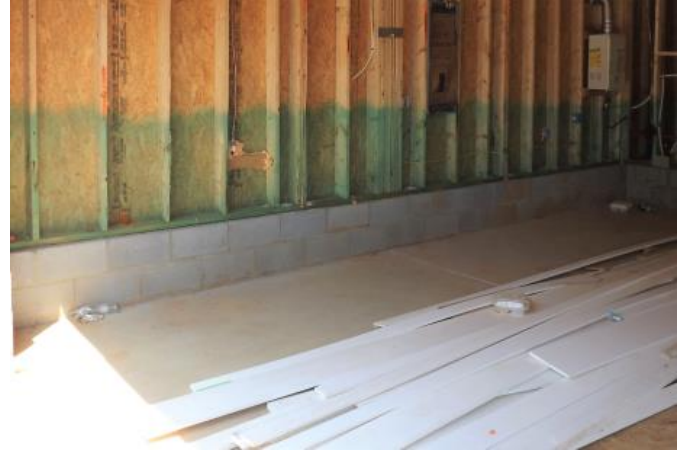
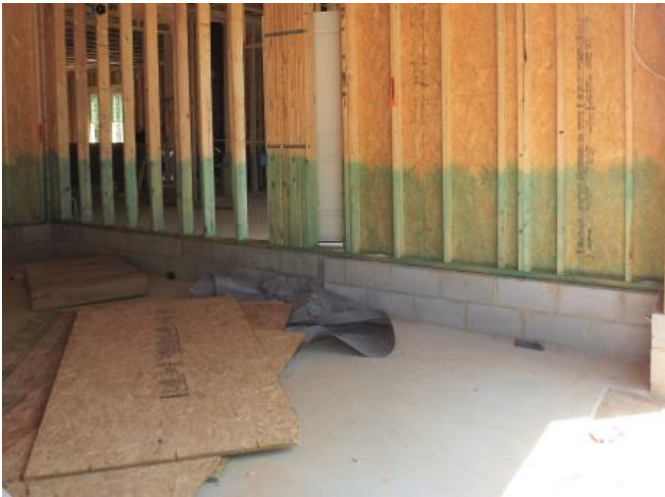
The garage foundation primarily appeared to be in serviceable condition at the time of the inspection. Observed damaged CMU block at Left rear corner. Recommend further review with builder for repairs as needed. Limited inspection due to construction material present.

Cracked CMU block.

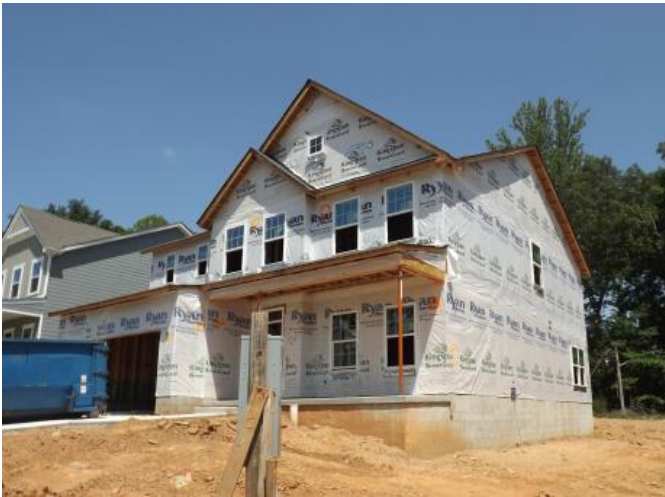
The visible and accessible portions of the exterior wall coverings primarily appeared to be in serviceable condition at the time of the inspection. Observed loose tape / house wrap at front and missing section of house wrap at front Right side. Recommend further review with builder for repairs / taping as needed.

Loose tape / house wrap at front.

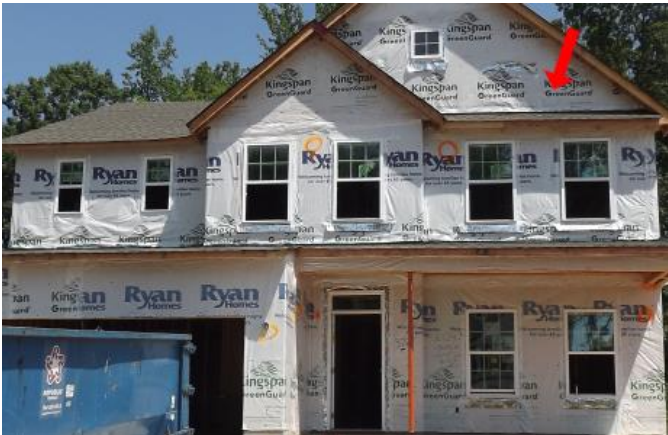
Broken glass pane(s) were observed at second floor front window. Recommend further review with builder for repair / replacement as needed.

Cracked window at second floor.

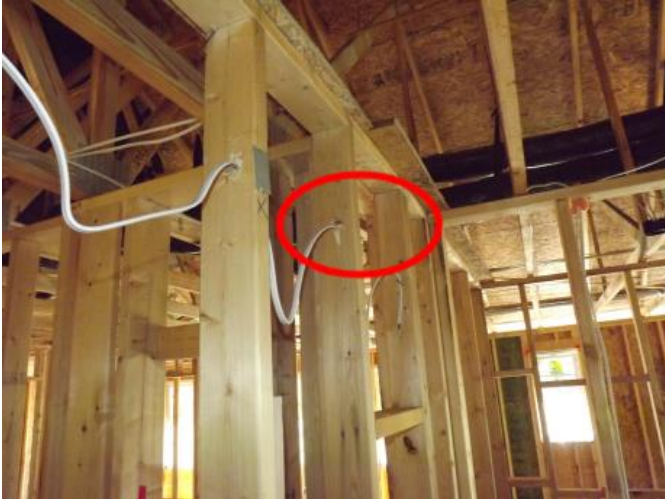
Wall Conditions	6.1	<p>Observed missing stud guards at various locations including first and second levels. Stud guards protect electrical wiring and plumbing lines from fastener damage when drywall is installed. Recommend further review of all studs to ensure stud guards are present as needed.</p> <p>Observed loose anchor bolt fasteners at various locations of the perimeter sill plates. This can effect the stability and strength of the exterior wall structure. Recommend further review to ensure all anchor bolt nuts are properly secured as needed.</p> <p>Observed missing stud strap at rear entrance. Stud straps or ties reinforce and strengthen the wall structure and assist with stabilizing the wall and roof in the event of high winds. Recommend further review with builder to ensure stud straps are present as needed.</p>
Floor Conditions	6.3	<p>The general condition of the visible and accessible portions of the floors primarily appeared to be in serviceable condition at the time of the inspection. Observed damaged concrete at kitchen plumbing lines. Recommend review with builder for further evaluation and repairs as needed.</p>

Missing stud guards at master bath.

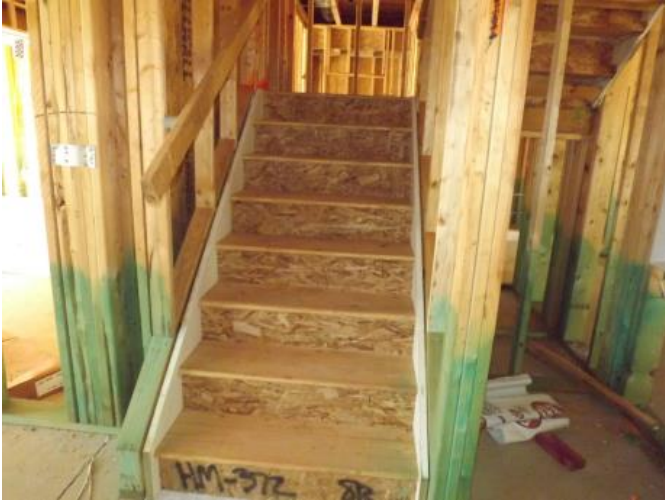
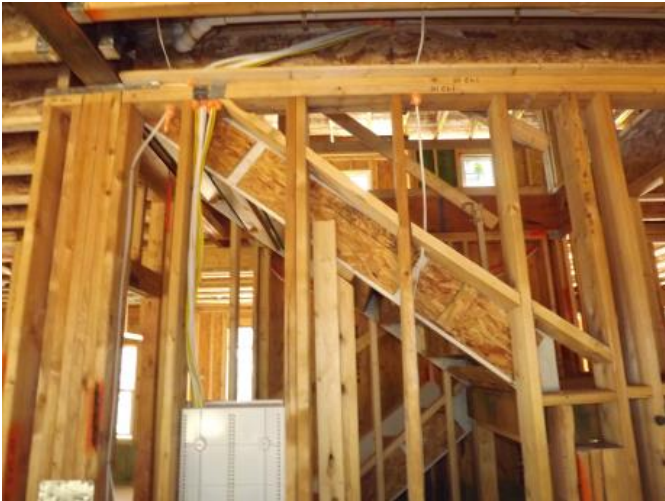
Observed damaged bottom lateral support at stairs. This can effect the strength and stability of the stair system. Recommend review with builder for further evaluation and repairs as needed.

Cracked / damaged support at underside of stairs.

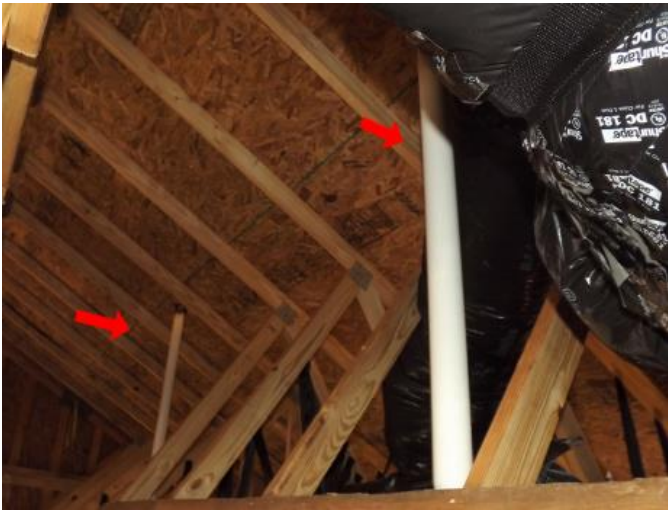
The plumbing vent pipe(s) appeared to be in serviceable condition at the time of the inspection.

Plumbing vent pipes.

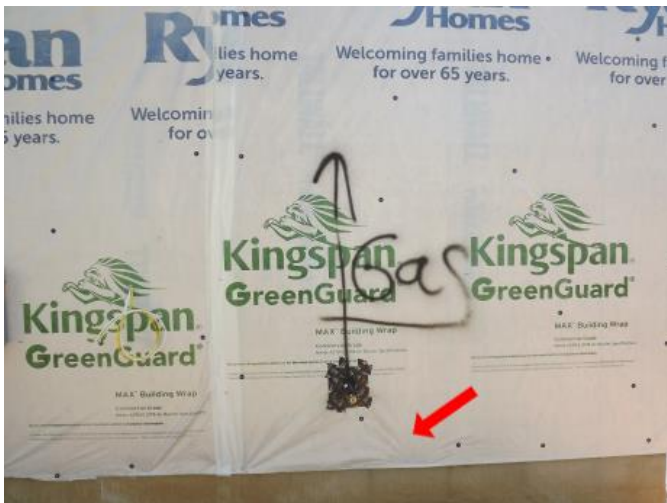
Not present. Will be located at Left side exterior.

Gas meter location.

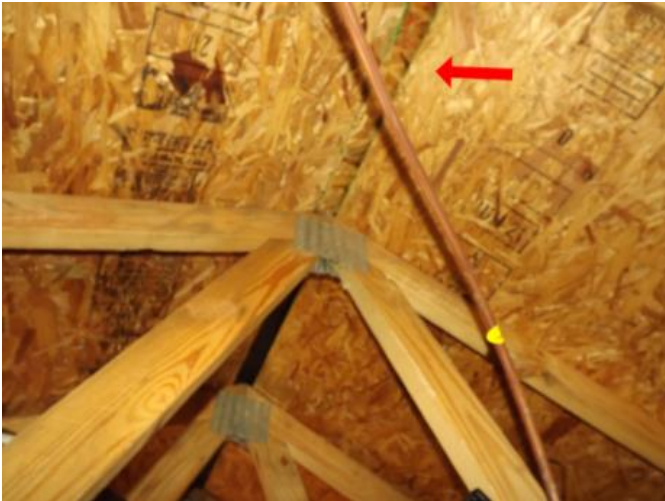
Observed blocked areas of the ridge vents. OSB sheathing present at ridge vent. This can effect the flow of air through the attic space and can reduce the source of combustion air for the gas furnace. Recommend review with builder for further evaluation and repairs as needed.

Sheathing at ridge vent.

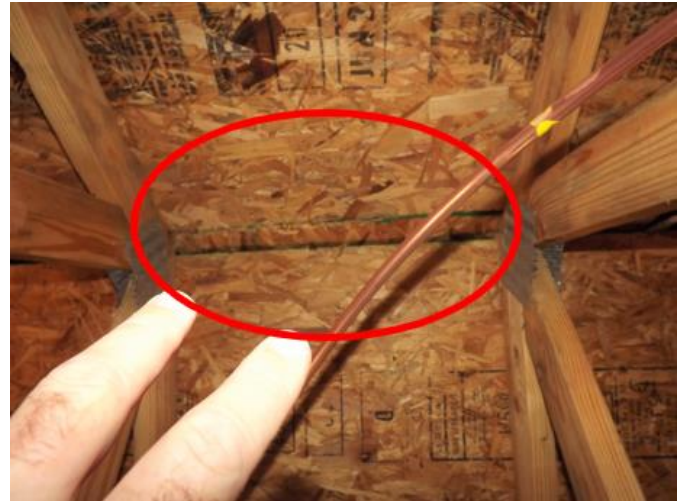
Sheathing at ridge vent.

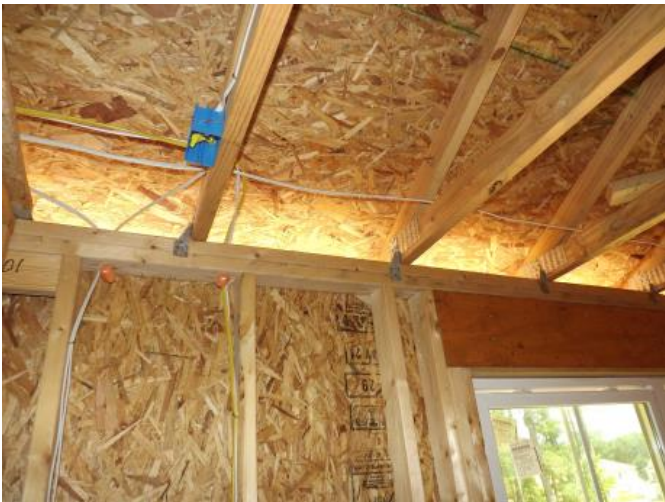
Soffit vents serviceable.
